Theatre of Magic Trunk Fix

Resolution to the ToM Bug Causing Trunk Lockout

P/N TPP-1039

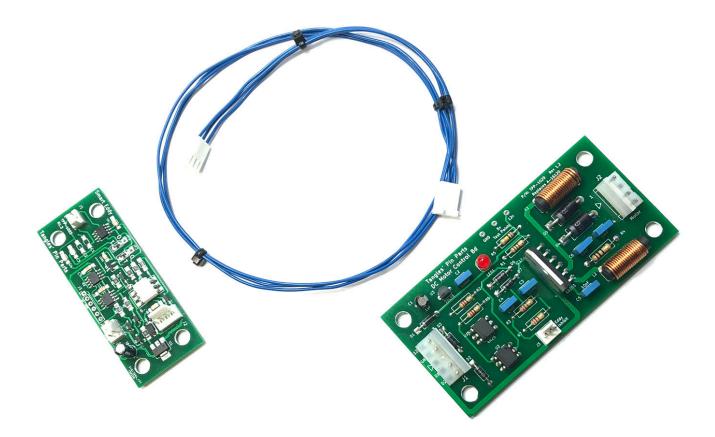
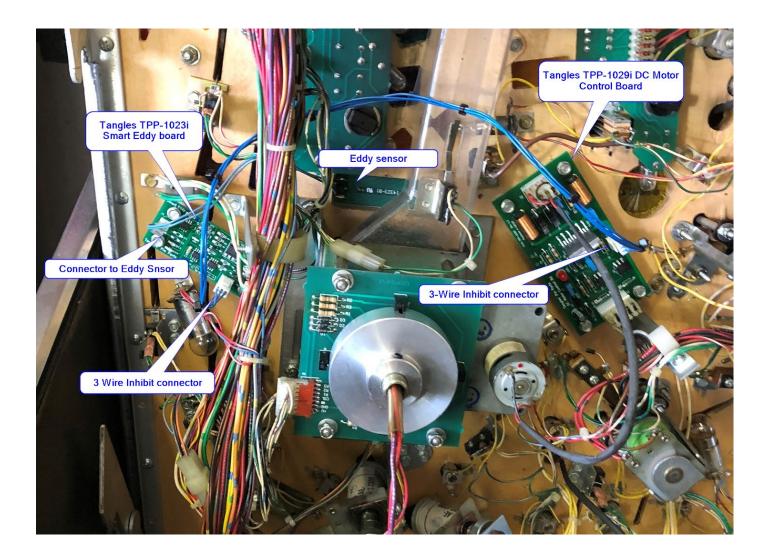
- Install the Smart Eddy Board (replacing the trunk eddy board).
- Connect the 2 pin Eddy sensor.
- Connect the 4 pin power/signal connector.
- Install the DC Motor Driver board (replacing the original)
- Connect the trunk motor to the 4-way header.
- Connect the power/signal to the 5-way header.
- Install the 3-Wire "inhibit" cable from Trunk Smart Eddy to the DC Motor Board.
- Route the 3-wire cable under the wiring loom to stay clear of trunk opto.
